Report
Pavement and Geotechnical Engineering Services
Broken Oak Drive
Wildwood, Sumter County, Florida

Project Number: 07572627
September 8, 2021

RE: Report
Pavement and Geotechnical Engineering Services
Broken Oak Drive
Wildwood, Sumter County, Florida

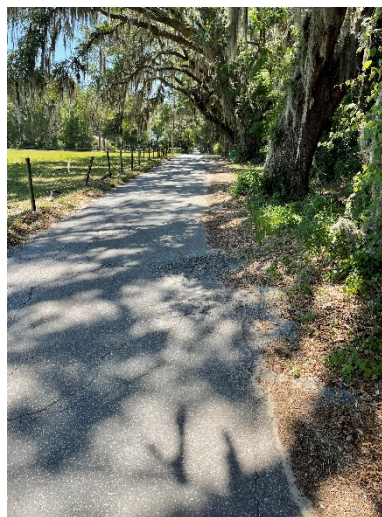
Photo 1: Tree roots under the asphalt pavement

Remove full depth of the existing pavement section. Any unsuitable materials (i.e. peat/organic soils/clayey soils) below the exposed excavated grade shall be removed to their full depth and hauled off the site. Clayey soils (A-2-6 and A-6 materials) and tree roots, where encountered, should be removed within 2 feet of the bottom of the new pavement base and backfilled with materials consistent with Strata 1 (AASHTO A-3 sands) or engineered fill. Compact the exposed subgrade soils to at least 98 percent of the material's modified Proctor (ASTM D-1557) maximum dry density. Construct the new flexible pavement following the below recommendations:

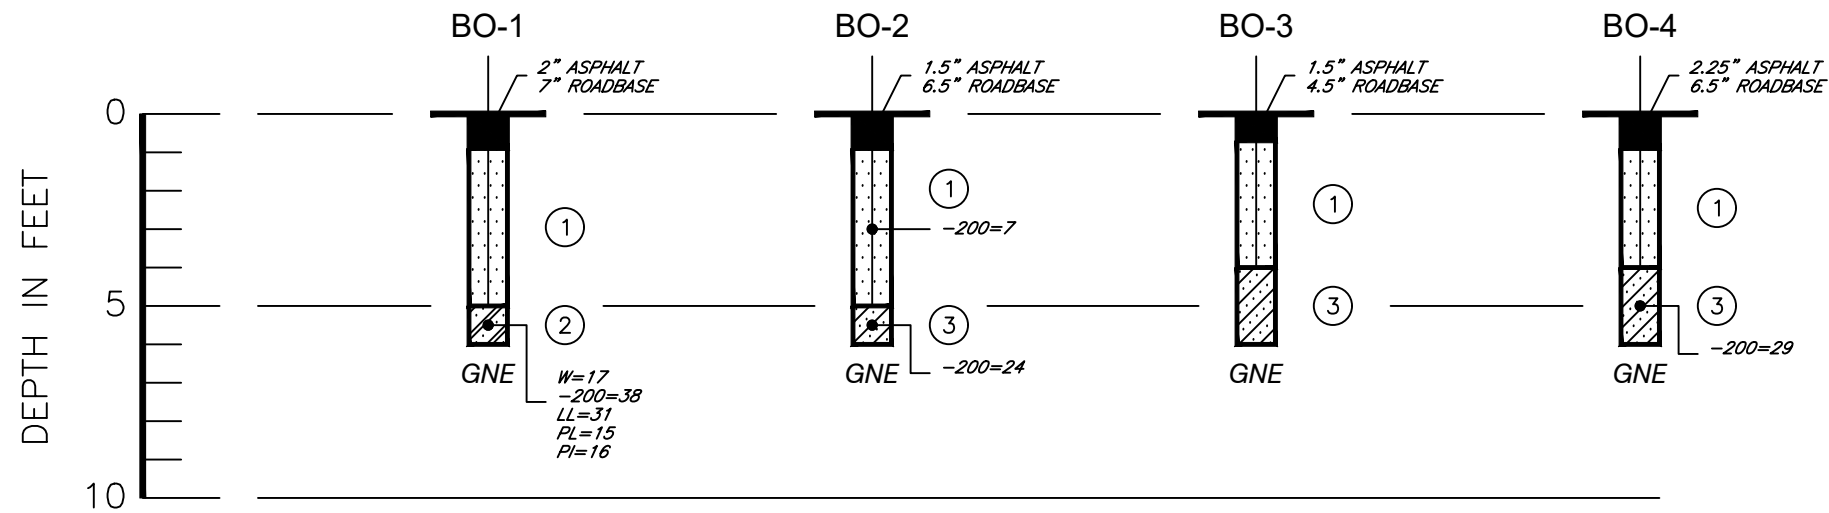
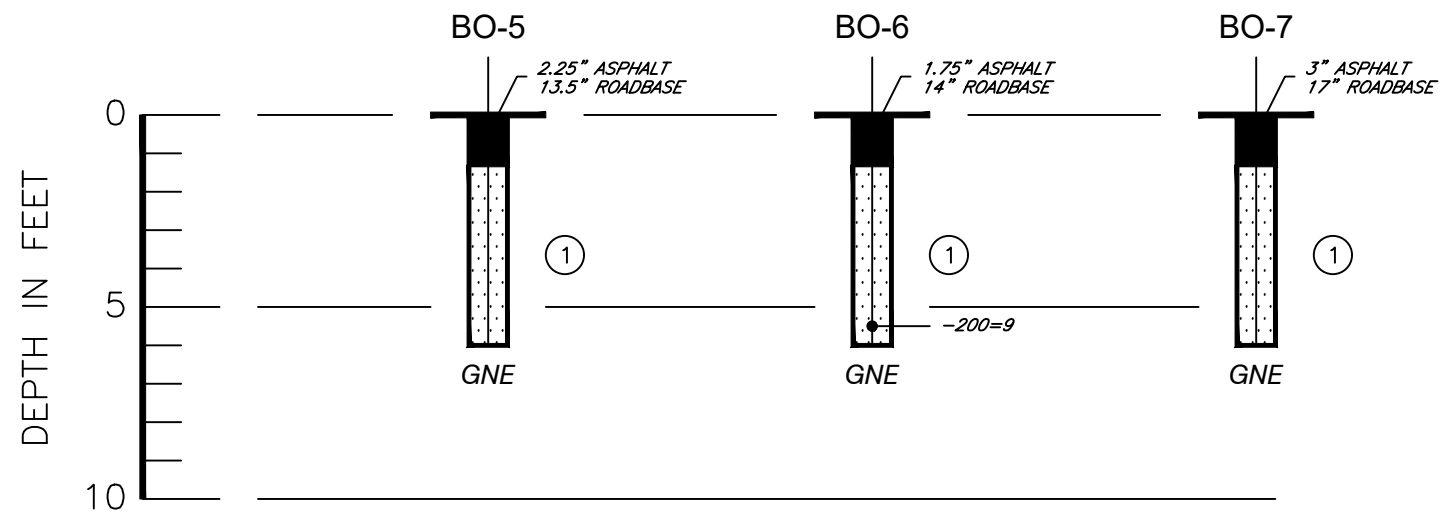
SOIL PROFILES

Based on the pavement borings PSI completed for the project, subsurface conditions are relatively consistent along the limits of the roadway. In general, the upper 4 to 6 feet of the borings revealed a series of fine sands grading relatively clean to slightly silty in composition (i.e. A-3 material). The upper sands were underlain by a series of clayey soils ranging from clayey fine sand to sandy clay (i.e. A-2-6 and A-6 materials).

A detailed description of the individual pavement borings are shown as soil profiles on **Sheet 2** of the **Appendix A**.

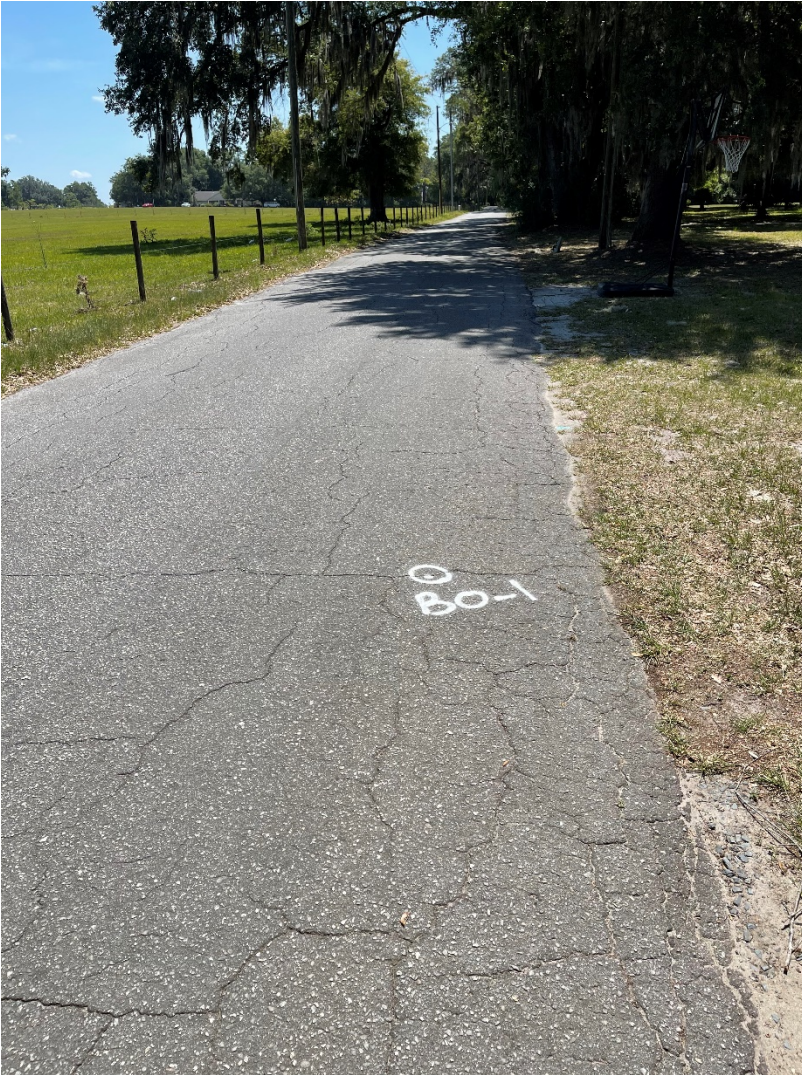
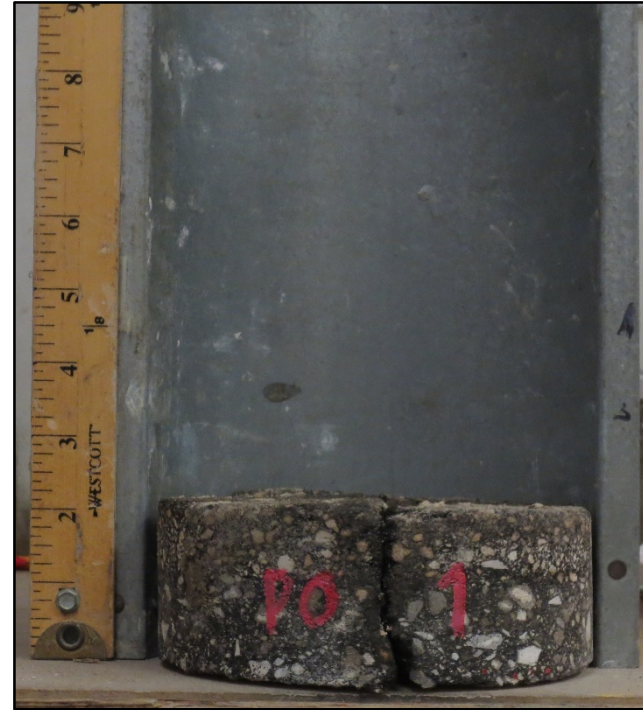
- Asphalt: 2 inches
- Pavement Base: 7 inches soil cement

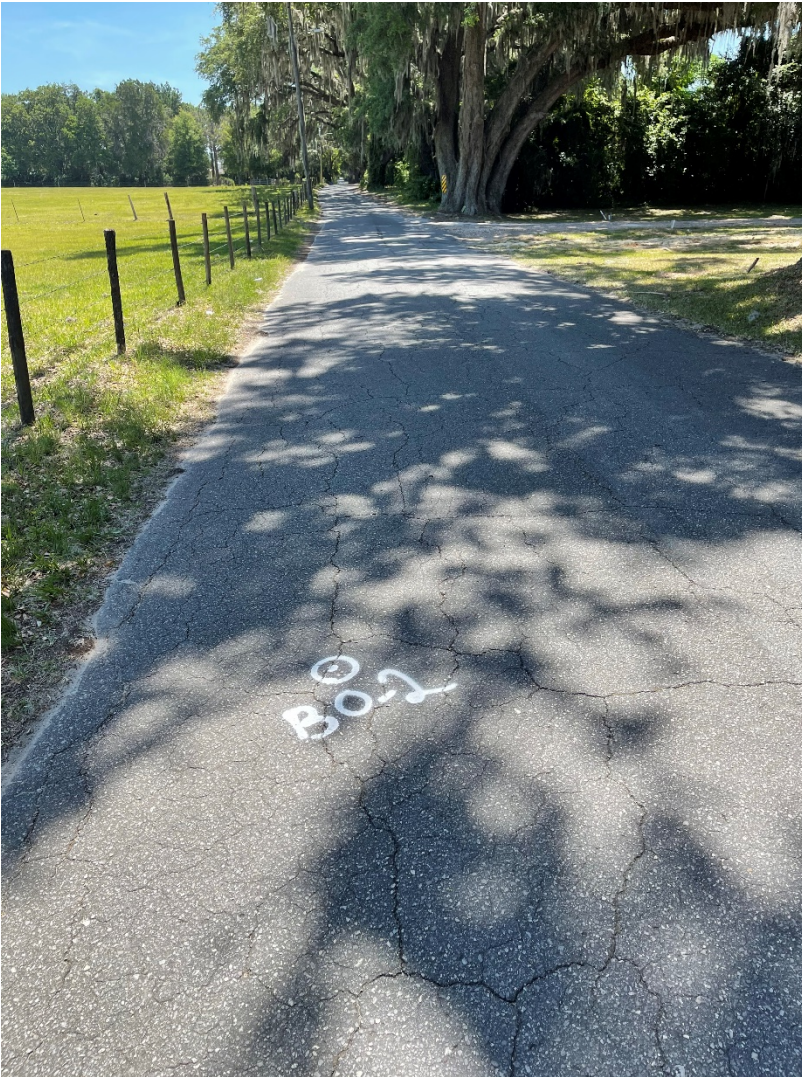
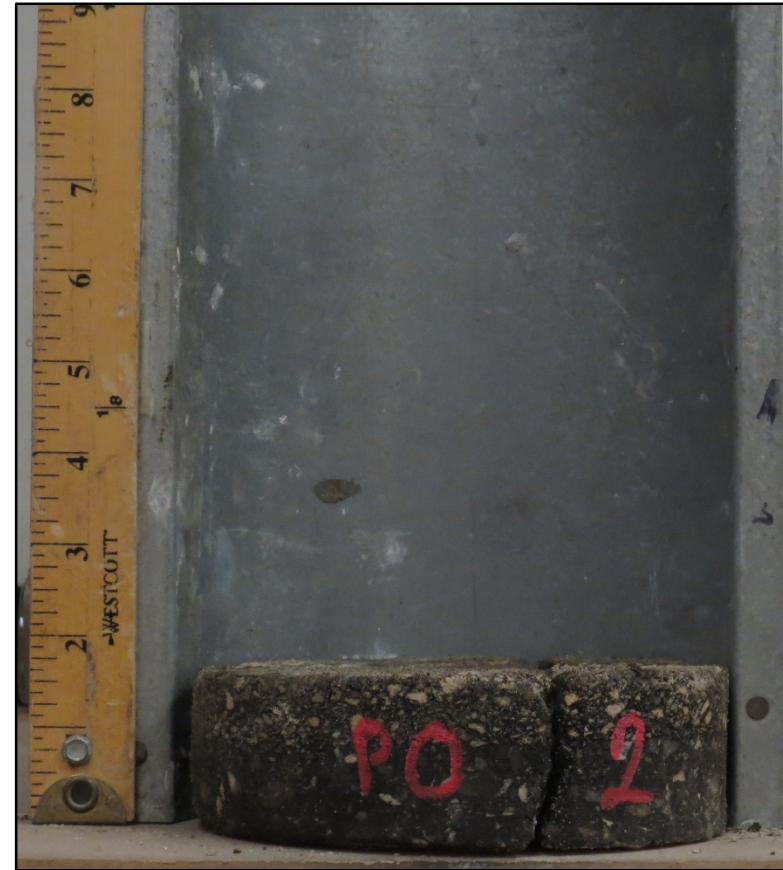
- Asphalt: 1.5 inch
- Pavement Base: 6.5 inches soil cement

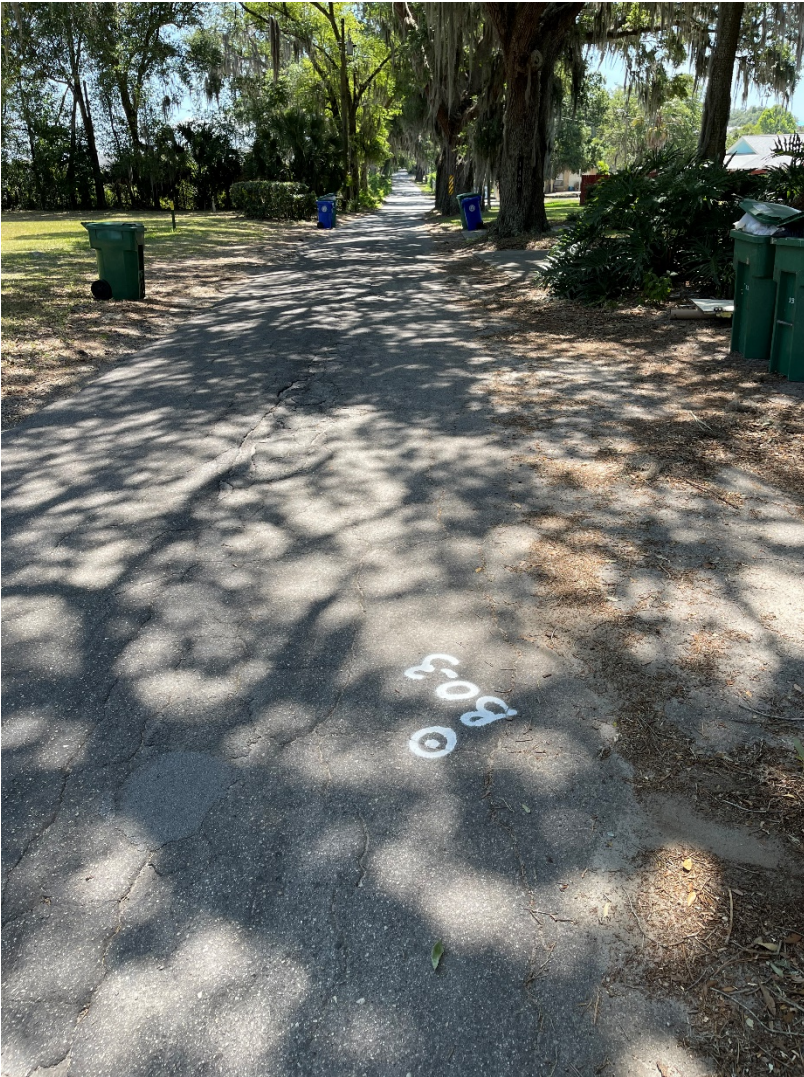
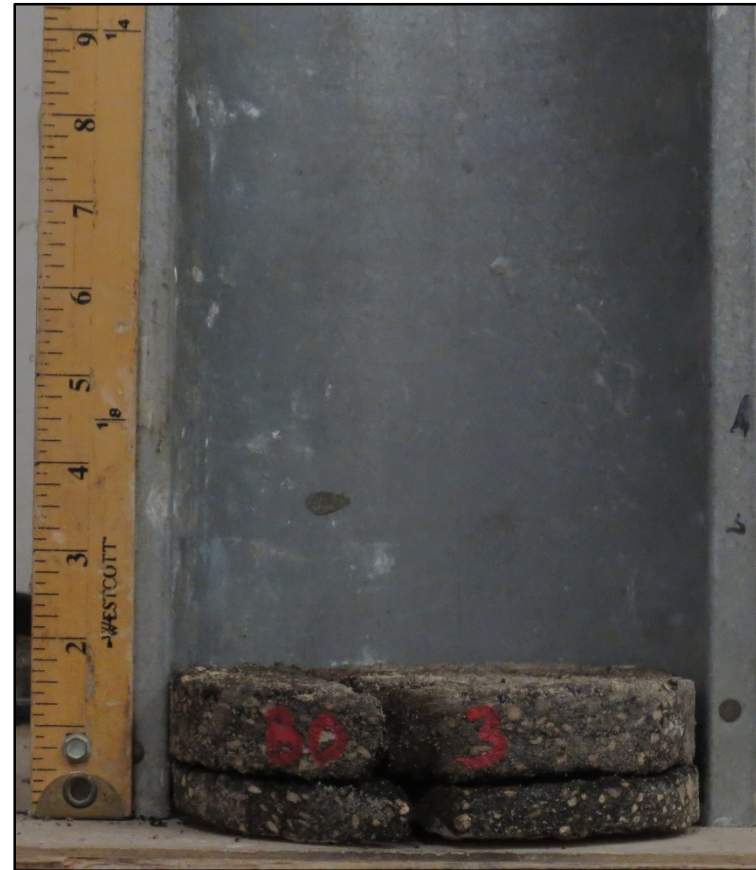
- Asphalt: 1.5 inches
- Pavement Base: 4.5 inches of limerock

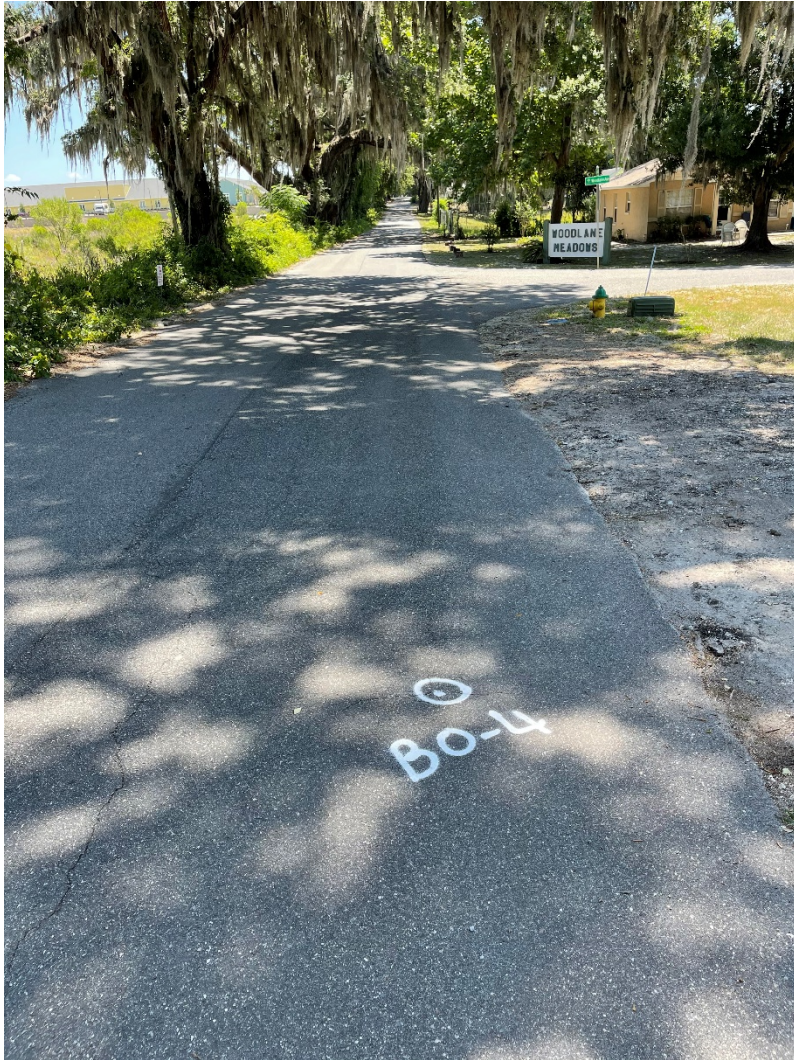
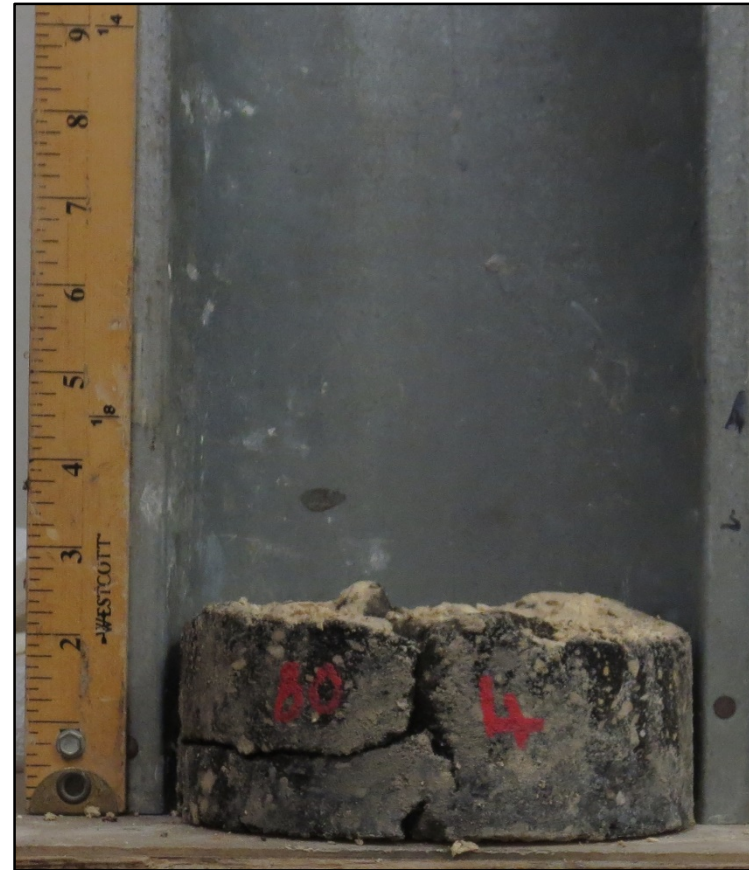
- Asphalt: 2.25 inches
- Pavement Base: 6.5 inches of limerock

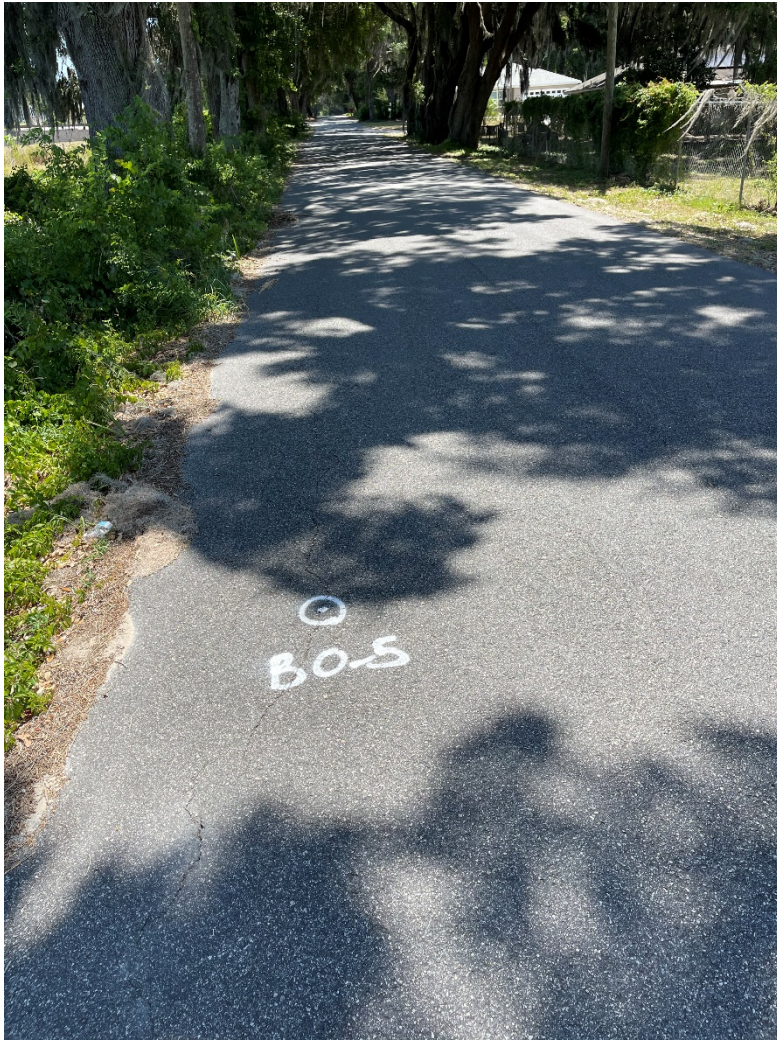
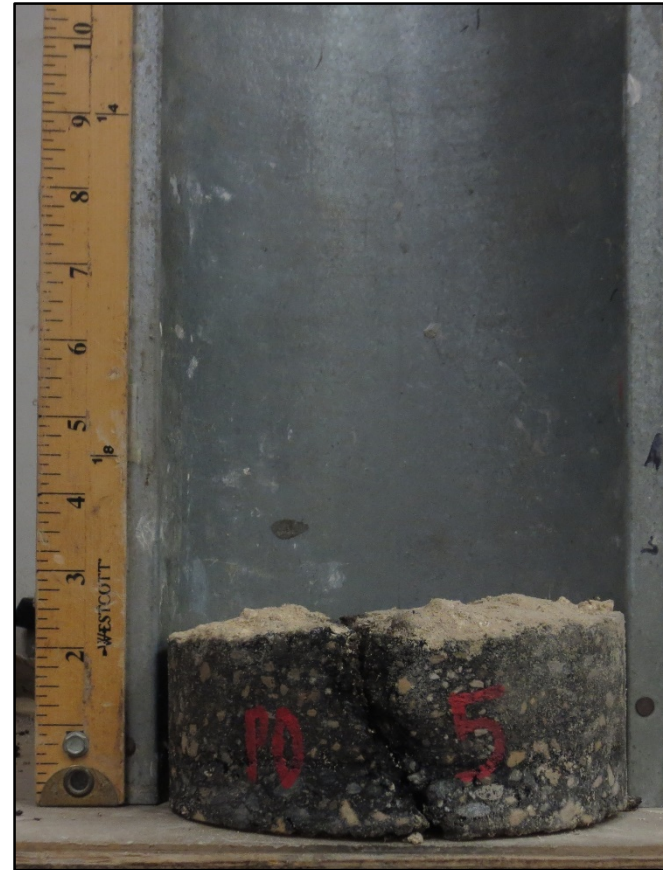
- Asphalt: 2.25 inches
- Pavement Base: 13.5 inches of limerock

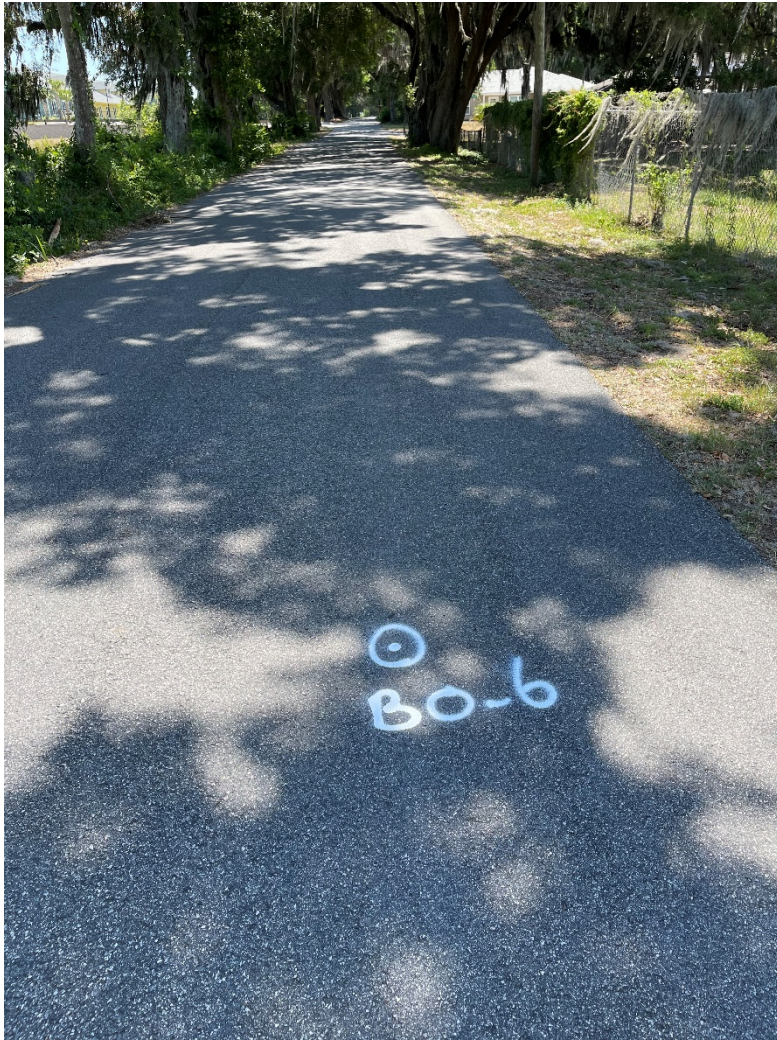
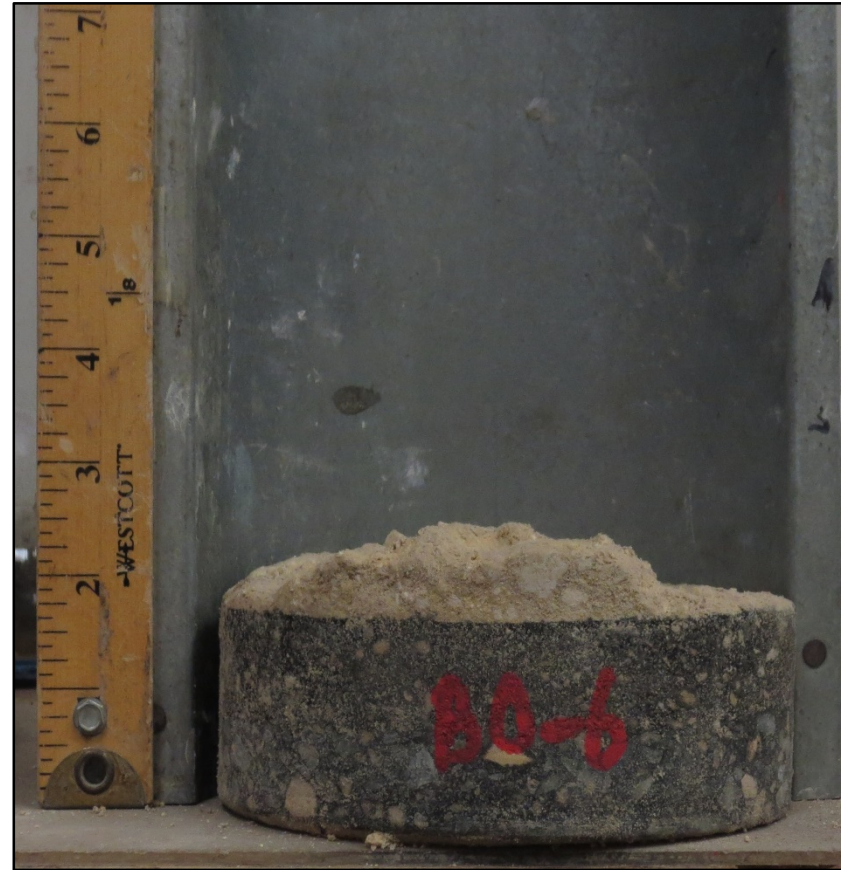
- Asphalt: 1.75 inches
- Pavement Base: 14 inches of limerock

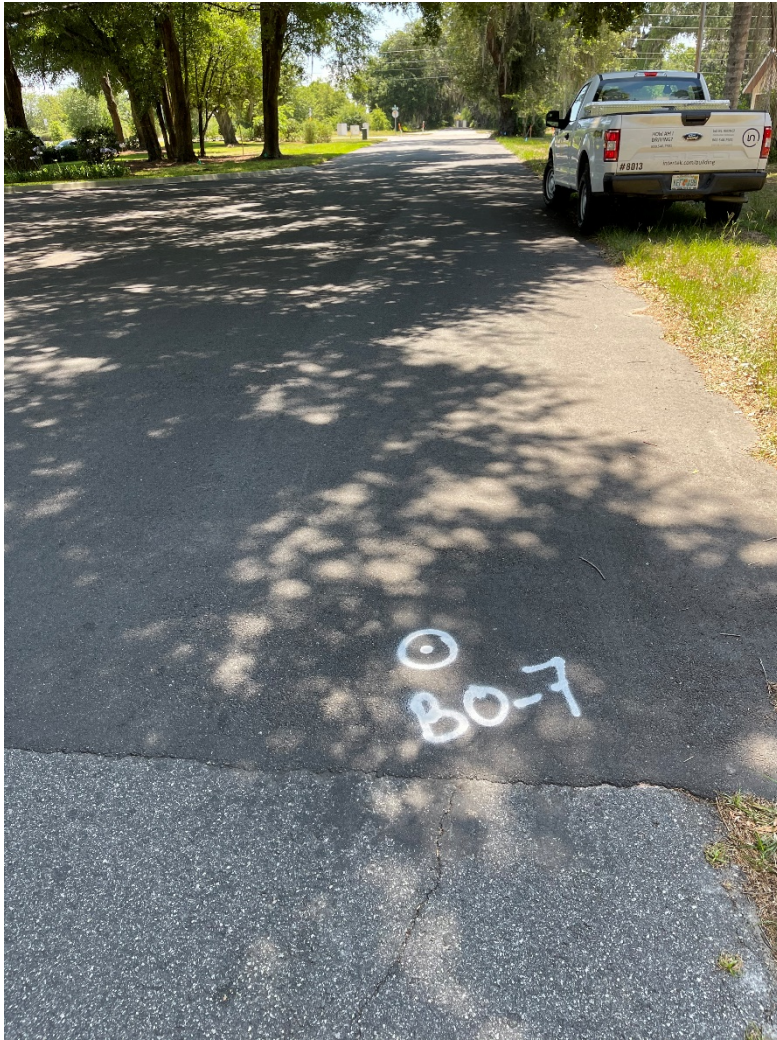
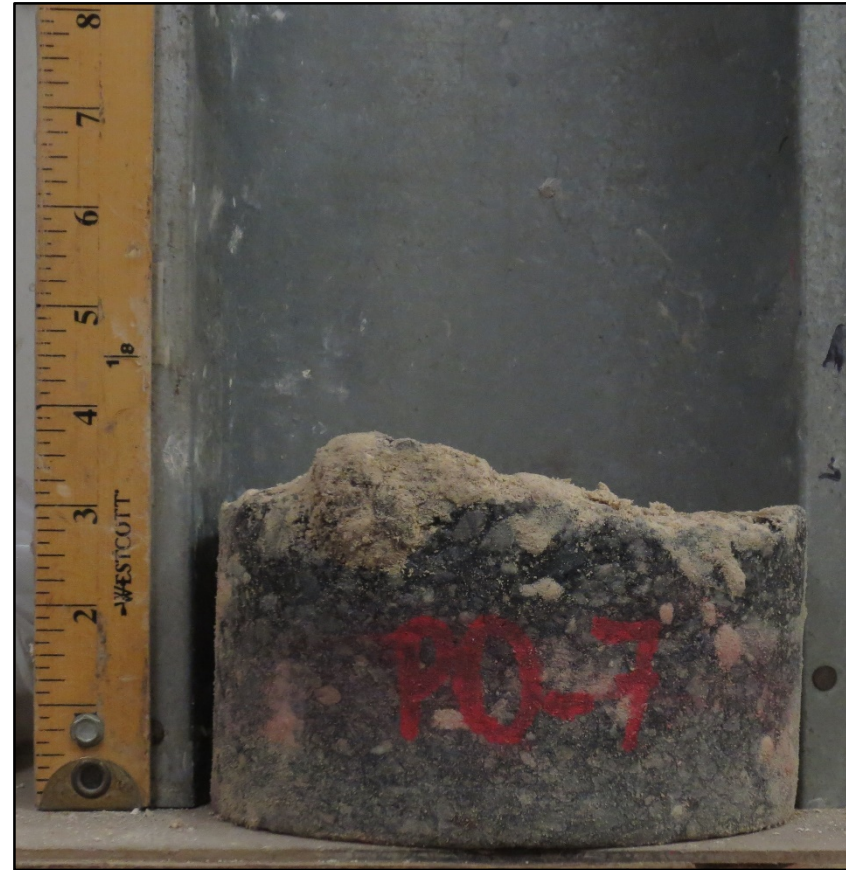
- Asphalt: 3 inches
- Pavement Base: 17 inches of limerock
